Test Report of Improved Backhoe

July 2003

Institute for Defense Analyses
4850 Mark Center Drive
Alexandria, VA 22311-1882

**Humanitarian Demining Research
and Development Program**
US Army RDECOM CERDEC
Night Vision and Electronic Sensors Directorate
10221 Burbeck Road
Fort Belvoir, VA 22060

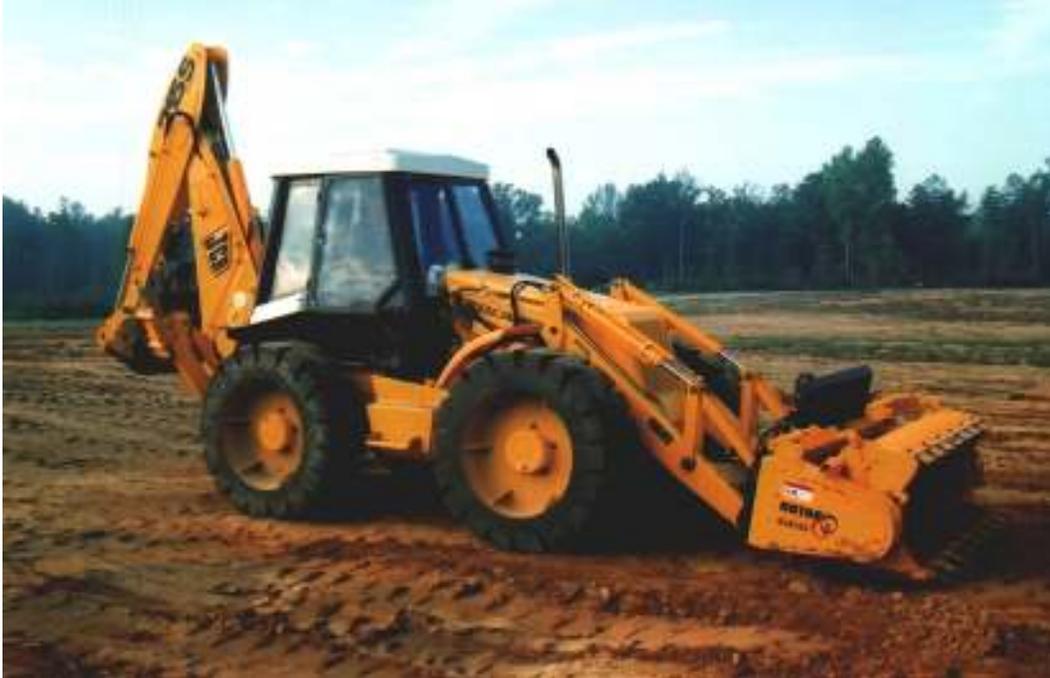
Figure 1. Improved Backhoe With HPL 800 S ROTAR[®]

Starting with a JCB 215S, Series 3, 4WS (also capable of 2 wheel steer (2WS) and crab steer) commercial backhoe, the Modeling and Mechanical Fabrication Shop of the U.S. Army Communications & Electronics Command, Night Vision and Electronic Sensors Directorate (NVESD), Ft. Belvoir, Virginia, made structural modifications to the vehicle to improve its survivability in a hostile, land-mine environment. The modifications included a blast-resistant cab and armored chassis intended to protect the operator and the vehicle from a small-arms fire (up to 12.75 mm) attack and from shrapnel caused by a detonated AP mine under the vehicle or an anti-tank (AT) mine in near proximity to the vehicle. (An AT mine detonated under the improved backhoe would more than likely disable the vehicle and cause injury to the operator.)

- The fiberglass engine cowling¹ was replaced with 12.7 mm (0.5 inch) 6061 aluminum plate. This plating was also installed under the engine and cab area of the body. A 6.35-mm (0.25-in.) T-1 steel blast plate was mounted across the front lifting arms to protect the hydraulic lines from AP and AT mine shrapnel.
- The fiberglass shell of the cab was replaced with 6.35-mm (0.25-in.) T-1 steel. The fore and aft wind screen and side curtains were replaced with 31.75 mm (1.25 in.) of LEXAN^{®2}. Exposed vehicle hydraulic lines were hardened to withstand fragmentation damage.

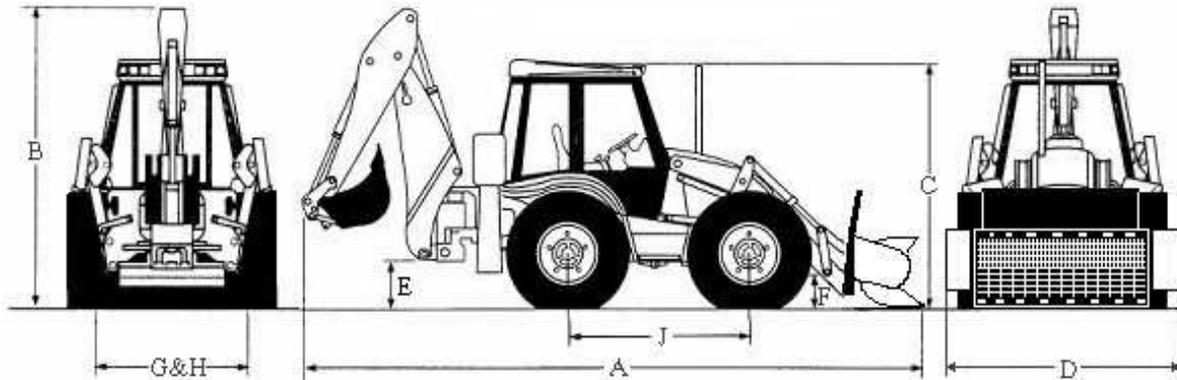
Figure 2. Silhouette of Improved Backhoe

Figure 2 provides a silhouette of the Improved Backhoe. The reader should refer to this figure when as he examines the measurement and weight information in Tables 1 and 2. If the 6-in-1 bucket is also shipped with the Improved Backhoe, an additional 1,830 pounds must be added to the weights in Table 2.

Note for Table 1: Letters refer to dimensions in Figure 2.

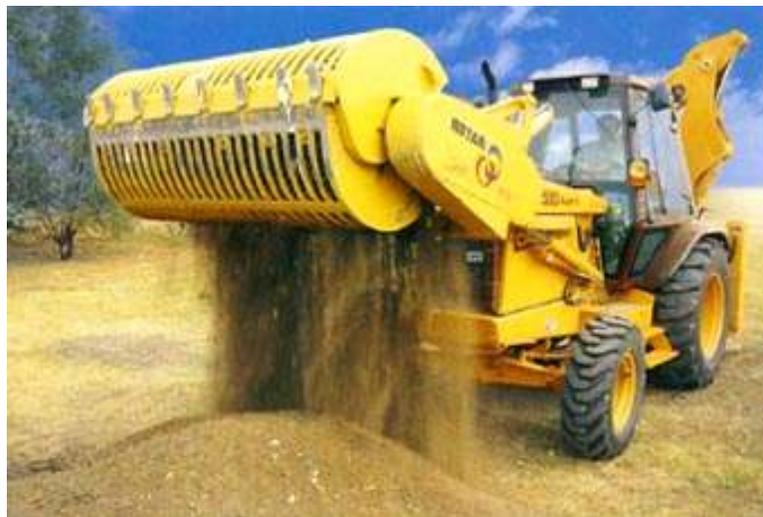
Figure 3. COTS ROTAR[®] Soil Sifter

The ROTAR[®] soil sifter, model HPL 800 S (manufactured by ROTAR[®] International, The Netherlands) used during this test was a COTS unit. The ROTAR[®] soil sifter comes in several sizes, ranging from light use to very heavy-duty use. Appendix A provides a list of over 600 commercial wheel loaders that will accept a ROTAR[®] soil sifter.

The ROTAR[®] model HPL 800 S selected for this test was mounted on the front loader arms of the JCB backhoe using the same attachment points used to mount the standard loader bucket. The NVESD Modeling and Mechanical Fabrication Shop manufactured the interface to mate the ROTAR[®] to the quick-disconnect mounting points. The ROTAR[®] barrel is constructed with 20-mm S2-3 steel bars to form a grid of 45-mm squares. Figure 3 is a picture of a COTS ROTAR[®] mounted to a wheel loader. Table 4 gives the specifications of the HPL 800 S ROTAR[®] sifter. Appendix B contains the specifications for the ROTAR[®] used in this test program.

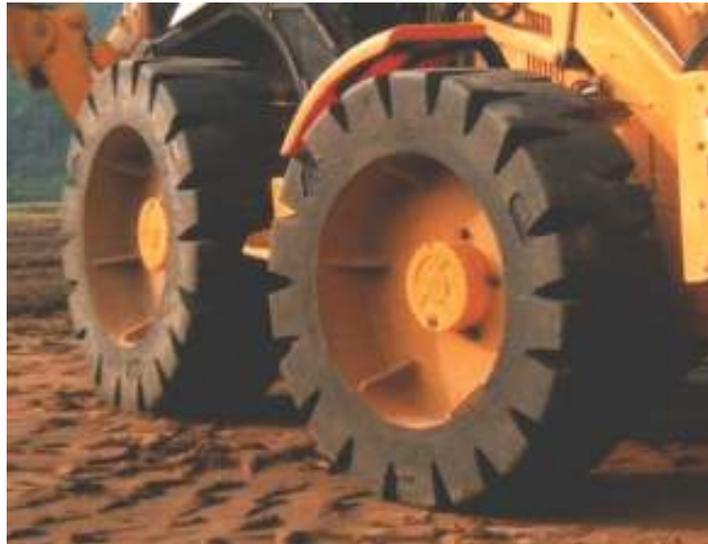
Figure 4. SETCO Solid Rubber Tire

The standard tires that came with the JCB backhoe were replaced with COTS SETCO solid rubber tires, manufactured by the SETCO Tire Company, Idabel, Oklahoma (see Figure 4). SETCO tires are a commercial product and are adaptable to any wheeled loader. Using SETCO tires (vs. standard tires) added 4,680 pounds (2,123 kg) to the gross vehicle weight of the Improved Backhoe.³ The SETCO tires will withstand the blast from a 500-gm AP mine, with only slight blast abrasion to the rubber tire and *no* damage/deformation to the metal tire rim.

³ SETCO tires sized to fit the JCB 215S weigh 1,650 lbs (748 kg) each. Standard tires weigh 480 lbs (218 kg) each.

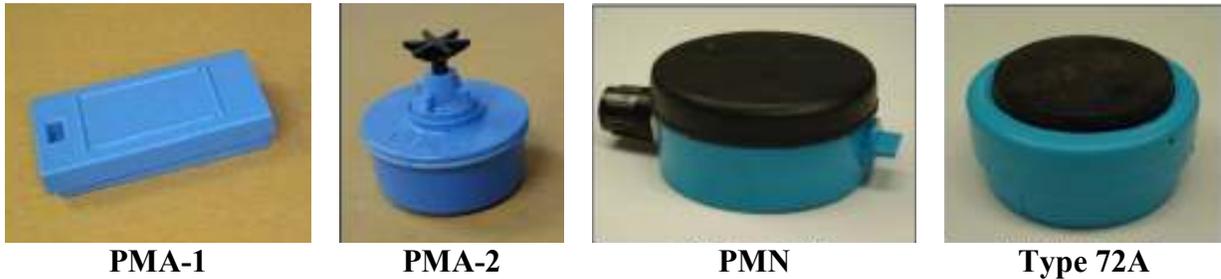
Figure 5. AP MRMs Used During ROTAR[®] Soil Sifter Operational Tests

All operational berm-cleaning tests of the ROTAR[®] soil sifter were made using AP mechanical reproduction mines (MRM) manufactured by Amtech Aeronautical Limited, Medicine Hat, Alberta, Canada. MRMs were buried in random patterns on the top and sides of the berms at depths ranging from surface to approximately 400 mm. The MRMs used were PMA-1, PMA-2, PMN, and Type 72A AP mines. Figure 5 shows pictures of the MRMs used during ROTAR[®] soil sifter operational tests.

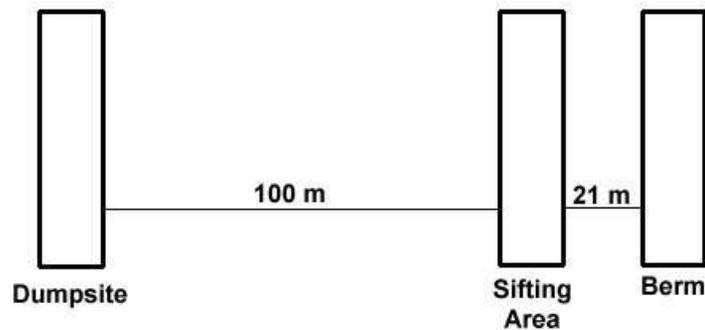
Figure 9. Berm-Clearing Schematic

In actual operation, the sifting area should be somewhat removed from the berm being cleaned for several reasons. First, the clean sifted dirt will occupy a greater volume than the dirt being cleaned until the cleaned dirt has had time to resettle. The more compact the dirt in the berm, the greater the volumetric difference between the sifted and unsifted dirt. Second, since there was a reasonable amount of spillage from the ROTAR[®] during dirt pickup at the berm, we found it better to have a clear demarcation area between the berm and the sifted dirt. The working distance used for the test was 21 m between the foot of the berm and the foot of the sifted-dirt berm. Figure 9 is a schematic showing the layout for the berm-clearing test.

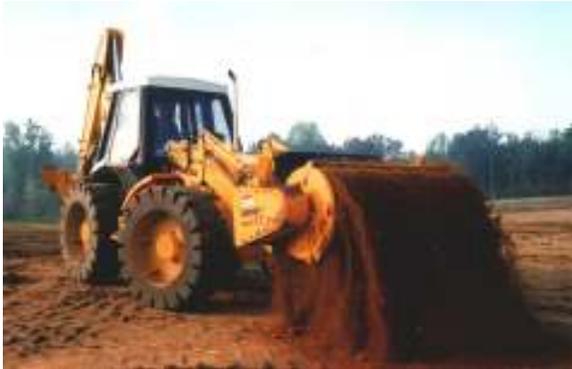
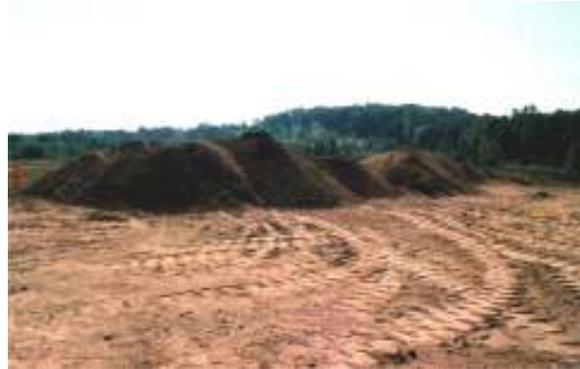
Figures 10 and 11 are pictures of the ROTAR[®] sifting berm soil and the sifted soil from the Test Site 1 berm.

Figure 10. ROTAR[®] Sifting Berm Soil

Figure 11. The Sifted Soil From the Test Site 1 Berm

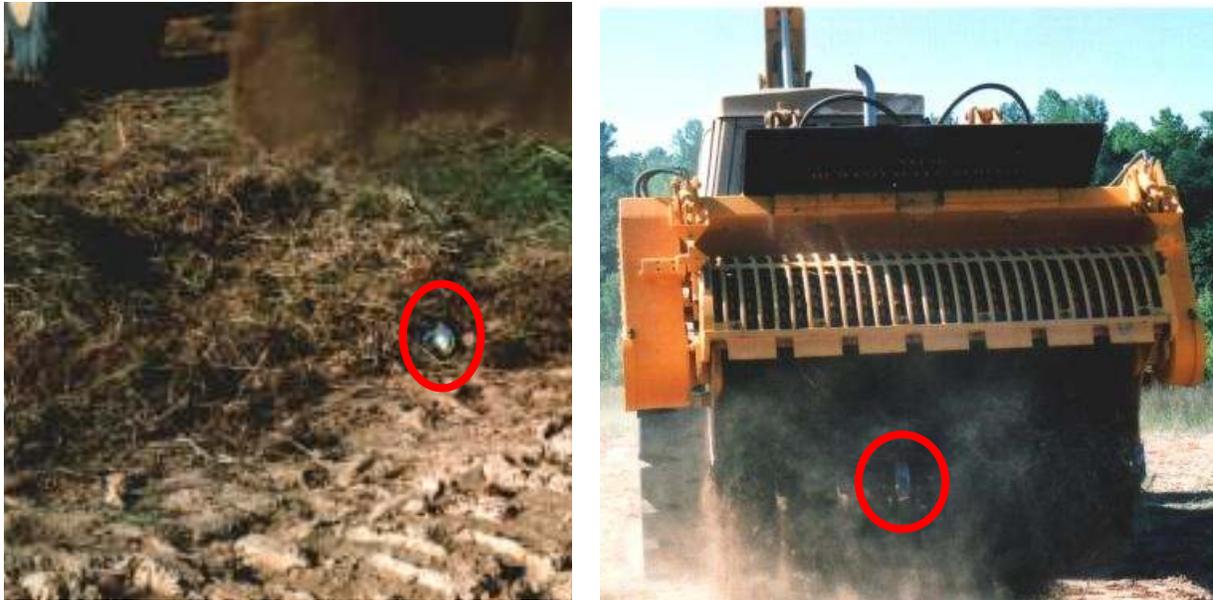
Figure 12. Mines Recovered by ROTAR[®]

The Test Site 1 berm was totally processed and leveled. In addition to the simulated mines, the ROTAR[®] also sifted out mortar training rounds and many pieces of debris including concertina wire, barbed wire, engine parts, pieces of railroad track, metal debris and the long grass growing on and buried in the berm. Figure 12 shows the mines recovered by the ROTAR[®].

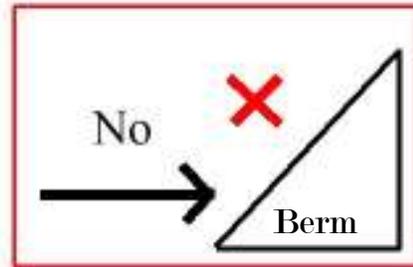
Figure 13. Loading Method Not Recommended

- Attempting to load the ROTAR[®] by pushing it into the berm, as someone operating a loader bucket would do, did not work well (see Figure 13). The optimal method for loading the ROTAR[®] barrel was to start with the ROTAR[®] at the bottom of the berm and raise the ROTAR[®] while slowly moving forward toward the berm (see Figure 14). This resulted in loading the ROTAR[®] while scraping up the face of the berm.

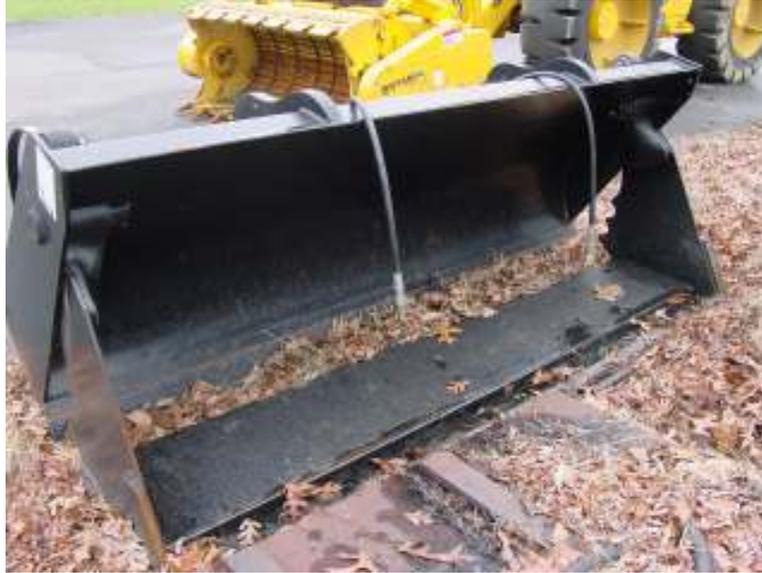
Figure 15. The 6-in-1 Bucket

The time required to remove the ROTAR[®] and install the 6-in-1 bucket was 10 min. After the sifted dirt was spread, the bucket was removed, and the ROTAR[®] was installed.

Again, the time lapse was 10 min. The change-out process was facilitated by having someone on the ground to guide the backhoe operator (whose vision was blocked by the steel blast shield on the lifting arms) in lining up the attachment points on the bucket or ROTAR[®] and the ends of the lifting arms.

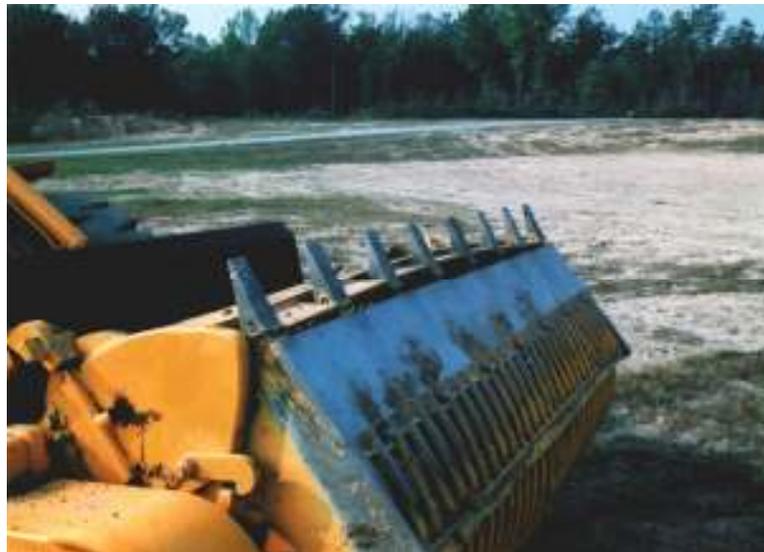
Figure 16. Blast Distortion (Bowing) to ROTAR[®]

length. Therefore, when the explosive test was conducted without dirt in the barrel, the explosive was suspended on the axis of rotation, at a point one-fourth the length of the barrel from the right side of the barrel. Table 8 presents the results of the explosive test in the ROTAR[®]. Some of the blast damage to the steel liner caused pieces of the steel liner to be pushed through the mesh of the reinforcing bars of the barrel. The protruding steel liner had to be beaten almost flush with the barrel bars to eliminate interference with the ROTAR[®] frame. Figure 16 is a picture of the bowing distortion to the ROTAR[®] barrel from the 1-lb block of TNT in Test 6. Figure 17 shows the damage to the steel liner from this series of tests.

Test No.	Weight of Explosive	Soil Contents	Damage to ROTAR [®]	ROTAR [®] Operable?
1	¼ lb	½ full	No damage.	Yes
2	½ lb	½ full	No damage.	Yes
3	1 lb	½ full	1-11/16" × 5/8" hole in steel barrel liner. Some outward bowing of longitudinal bars.	Yes
4	¼ lb	Empty	5" × 3" hole in steel barrel liner.	Yes
5	½ lb	Empty	13" × 4.5" hole in steel barrel liner.	Yes
6	1 lb	Empty	Pressure-rise tearing of steel barrel liner at juncture with end of barrel. Noticeable bowing of longitudinal barrel bars.	Yes. ROTAR [®] able to close, lock, and spin.

Blast tests were conducted using ¼-, ½-, and 1-lb (113, 227, 454 gm) charges of TNT against the ROTAR[®] both half full and empty of dirt. *After each blast test, regardless of the size of explosive charge used, the ROTAR[®] was fully functional and operable.* However, some damage was sustained. With dirt in the ROTAR[®], no damage was caused by the ¼- and ½-lb (113 and 227 grams) charges of TNT. The 1-lb charge of TNT, when detonated with dirt in the ROTAR[®], caused a hole to be punched through the steel liner and caused slight bowing of the horizontal bars. Without dirt in the ROTAR[®], damage was caused to the steel liner by each of the TNT charges (¼, ½, and 1 lb), and the bowing of the horizontal bars was noticeable after the 1-lb charge test.

Subsequent to the test, the horizontal bars were straightened and the steel liner was replaced.

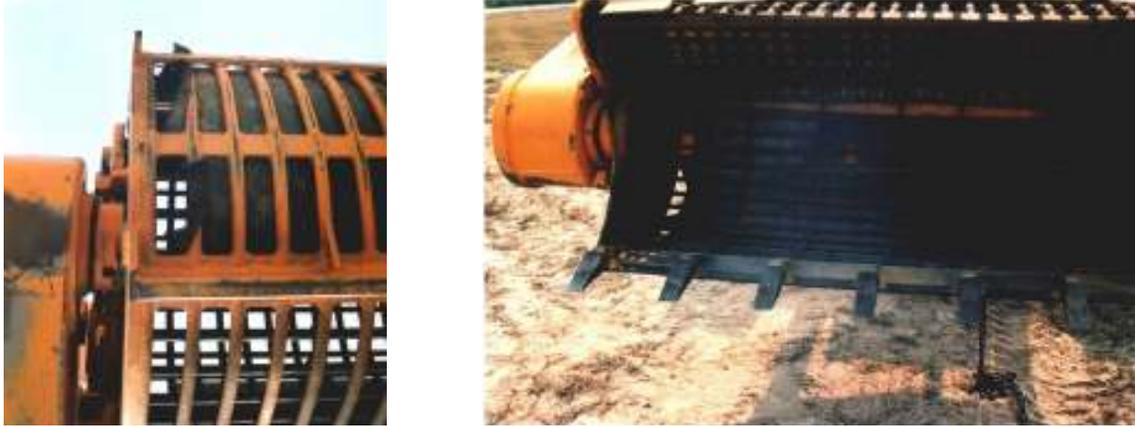
Figure 17. Blast Test Damage to Steel Liner

Six blast tests were conducted against the ROTAR[®]. The sizes of the explosive charges used were ¼-, ½-, and 1-lb blocks of TNT. Two blast tests were conducted for each size explosive: one with the ROTAR[®] barrel half filled with dirt (in which the explosive was buried) and the other with no dirt in the barrel (the explosive was suspended on the axis of rotation). In all cases, the explosive was remotely detonated. For the 1-lb explosive test, the test in the half-filled barrel resulted in damage to the barrel's steel liner at the midpoint of its

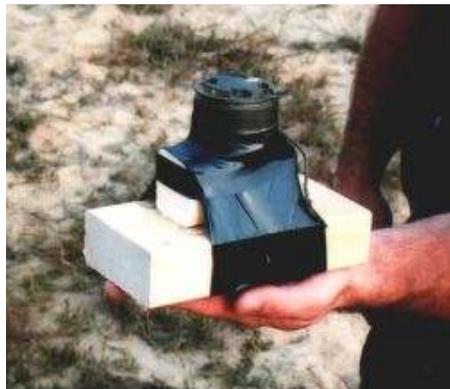
Figure 18. A 1-lb Explosive Charge

The blast test against the SETCO tires was designed to investigate two survivability issues. The first issue was to determine the ability of the SETCO tire to withstand repeated AP mine blasts (8 tests) at different points on the tire's diameter from ½-lb blocks of TNT. The second issue was to determine the ability of the SETCO tire to withstand the blast from a large AP mine containing 1 lb of TNT (9th test). Figure 18 shows a 1-lb explosive charge.

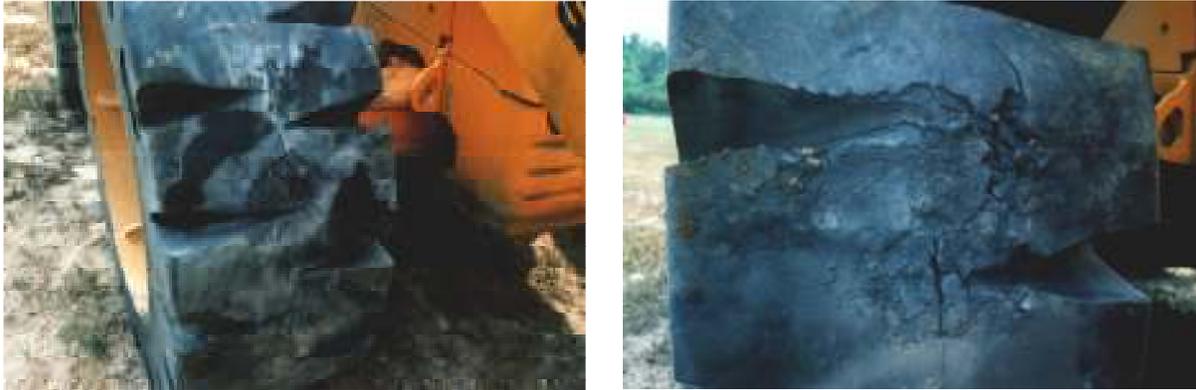
Figure 19. Tire Damage From ½-lb (left) and 1-lb (right) Mine Charge

The procedure followed in each test was to bury the block of TNT, to which a small AP mine had been taped to act as a fuse for the TNT. The mine and TNT were buried flush with the surface in front of the front right wheel of the Improved Backhoe vehicle. The soil in the test area was a dry sand-clay mixture. The Improved Backhoe was then pulled forward by another vehicle until the right front wheel rolled onto the AP/TNT mine causing a detonation. In all 8 tests with the ½-lb blocks of TNT, the damage to the tire was similar. The blast charred the tire and generally took an oval pattern in the 4–5 in. (102 mm–127 mm) by 6–8 in. (152 mm–203 mm) size range. Gouging of the tire face ranged in depth from 0.75 in. (19 mm) to 1.375 in. (35 mm). The mines were buried so detonation would occur near the center of the tire. Therefore, on almost all 8 tests, there was some splitting of the tire along the center mold seam at the point of the blast (1–2 in. long and 1+in. deep) (25–50 mm long and ~ 25

mm deep). Since the tire does not flex while being driven, there was no progression of the splits during subsequent use. The resultant blast crater was 12–15 in. (305–381 mm) in diameter and 8–12 in. (203–305 mm) deep, depending on the looseness of the soil. Surface scarring caused by blast forces escaping out from under the tire generally scrubbed the earth in a circular pattern out to about 44 in. (1,118 mm). Figure 19 shows the damage from ½-lb and 1-lb mine charges.

The test using the 1-lb block of TNT caused a bit more damage but in no way incapacitated the operation of the Improved Backhoe. The damage to the face of the tire by the blast measured about 6 in. (152 mm) in diameter, with cracks penetrating to a depth of 1.5 in. (38 mm). The blast crater was about 20 in. (508 mm) in diameter and 15 in. (381 mm) deep. The surface scrubbing created a circle of 58 in. (1,473 mm).

A single SETCO tire was subjected to 9 blast tests: 8 blasts of a small AP mine and ½ lb (227 grams) of TNT and 1 blast of an M14 AP mine and a 1 lb (454 grams) of TNT. The ½-lb charge of TNT caused minimal abrasion to the face of the tire. The 1-lb charge of TNT caused only minor blast abrasion. When blasts took place directly under the mold seam of the tire, minor cracks at the seam line were evident. No damage was caused to the metal rim. Given the amount of damage to this tire, we estimate that this tire could withstand upwards of 100 blast occurrences before having to be replaced.

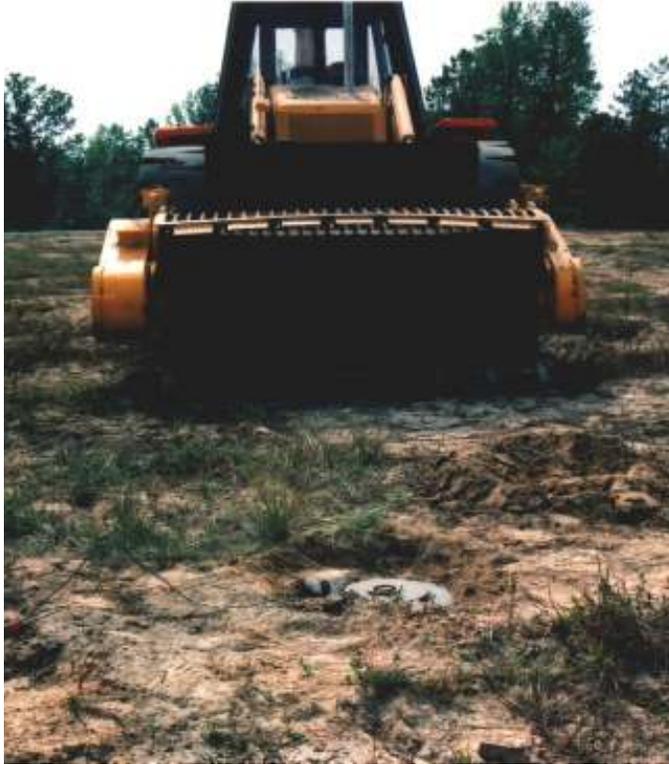
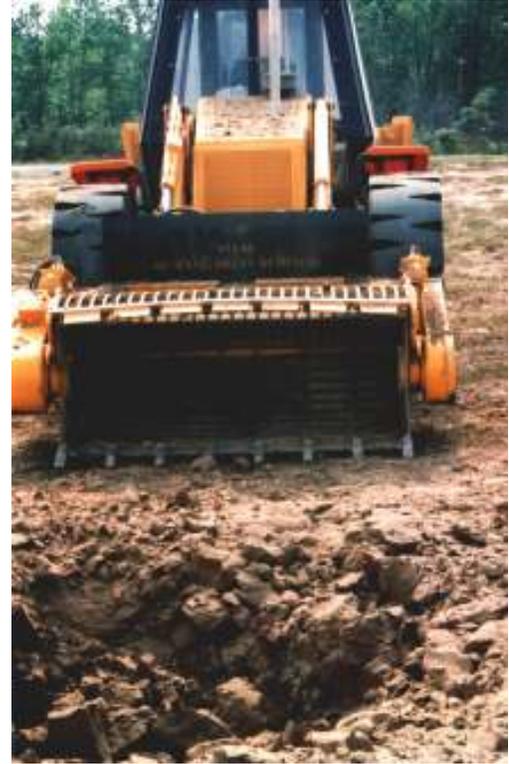
The Improved Backhoe was subjected to the blast affects of a 10 kg AT mine buried at a depth of 5 cm, at a distance of 3 m in front of the ROTAR[®] when the ROTAR[®] was in a normal, retracted position. For the test, the ROTAR[®] was lifted 8 cm off the ground. The purpose was to determine what damage might be caused by mine shrapnel and blast debris from an AT mine detonated within the working radius of the ROTAR[®]. The result was no visible damage to any part of the vehicle. Figure 20 shows the Improved Backhoe before AT mine detonation, and Figure 21 shows the Improved Backhoe after AT mine detonation.

Figure 20. Improved Backhoe Before AT Mine Detonation

Figure 21. Improved Backhoe After AT Mine Detonation

There was no noticeable degradation to the performance of the backhoe because of the additional weight from armoring the chassis and using the heavier SETCO tires. During blast tests on the ROTAR[®] and the SETCO tire, parts of the vehicle not subjected to the blast tests did not sustain any damage. The one blast test against the chassis (an AT mine set off in front of the vehicle) did not damage the backhoe.
